# **Mobile Intel<sup>®</sup> Celeron<sup>®</sup> Processor on .13 Micron Process in Micro-FCPGA Package Specification Update**

Release Date: February 2003

Order Number: 251309-008

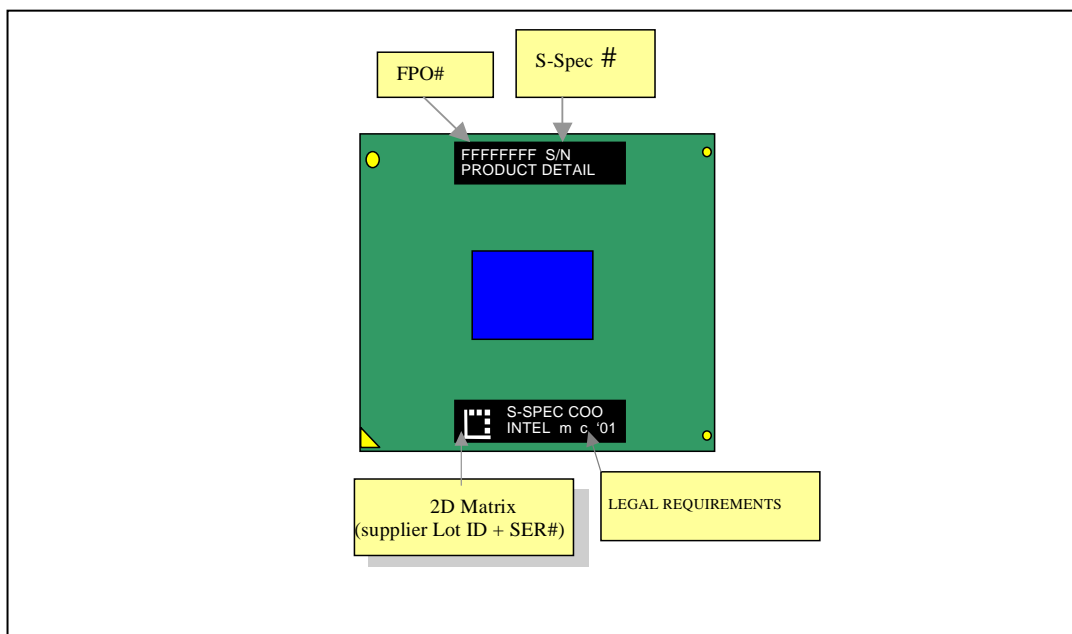
### *Mobile Intel® Celeron® Processor on .13 Micron Process (Micro-FCPGA) Markings*
